STUDY FOR OREWA BEACH REEF CHARITABLE TRUST - NAVIGATION AND SAFETY ASPECTS OF REEF DEVELOPMENT PROPOSAL AT OREWA BEACH

Larry Robbins OBE FNI
PO Box 35-401
Browns Bay
Auckland 0753

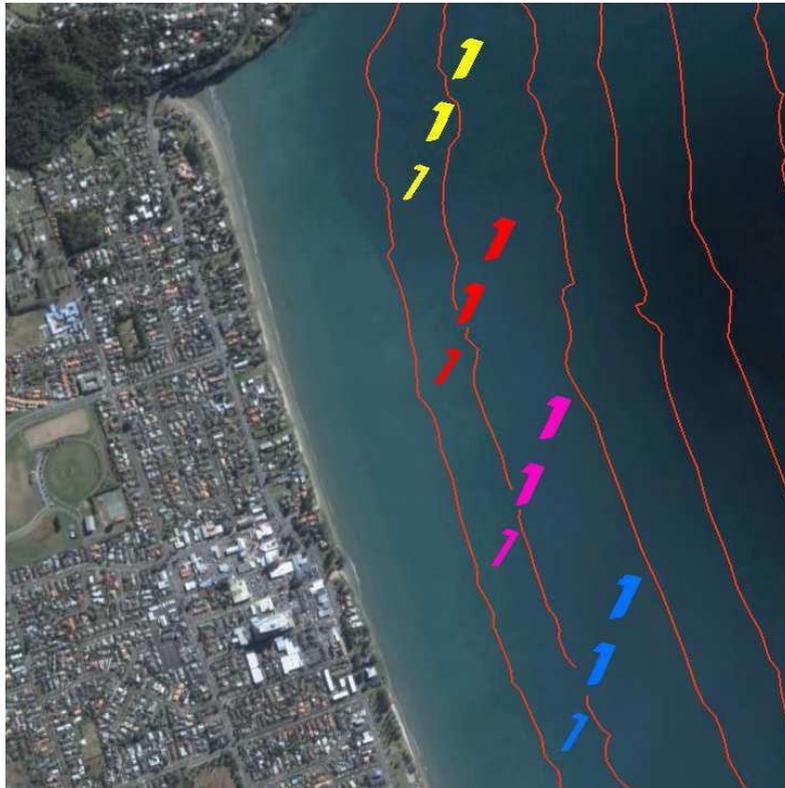
Figure 1 - Schematic Presentation of the Proposed Reef Structures from AEE Report

According to the AEE Report (Reference 4) the proposal is to construct a series of three individual reef structures at four separate locations offshore of Orewa Beach. Each individual structure is approximately 110-150 metres in length located obliquely to the line of Mean High Water Springs (MHWS). The schematic presentation of the proposed reef structures at figure 1 is taken from the AEE report and the equivalent area from the current navigational chart NZ5321 (Reference 5) is shown at figure 2 which also shows the approximate position of the proposed reefs.

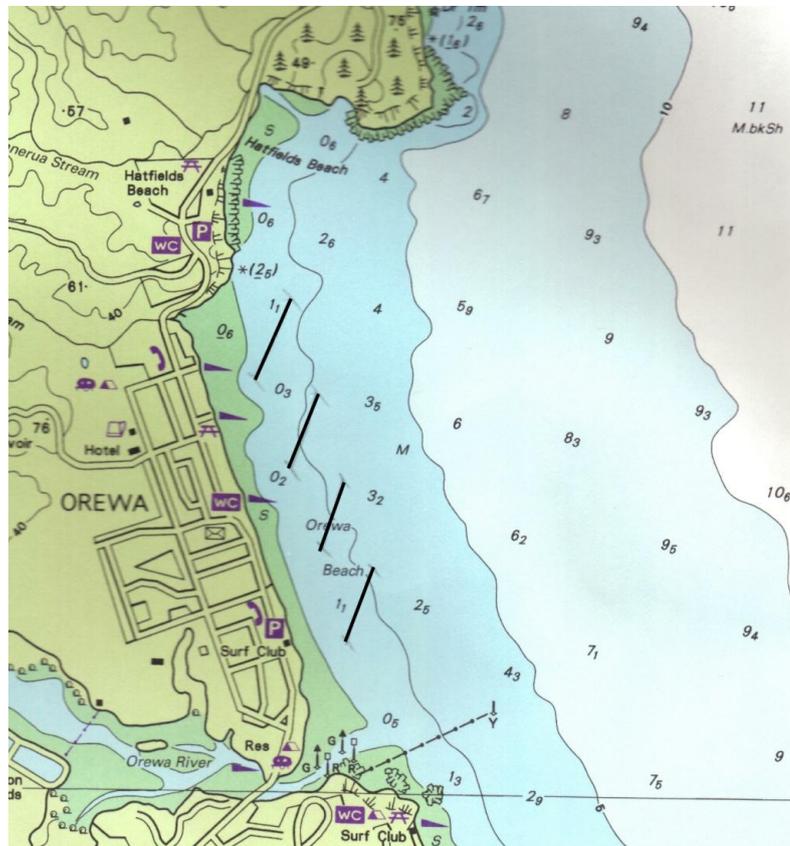
Figure 2 - Portion of Chart NZ 5321 (published in 2003) showing approximate position of proposed reefs

There is only one navigational mark charted in the area, a yellow beacon marking the end of the outfall to the east of the Orewa River entrance (shown in figure 2). The ski lane access markers (paragraph 3.3 above) are not charted. No boat ramp is charted.

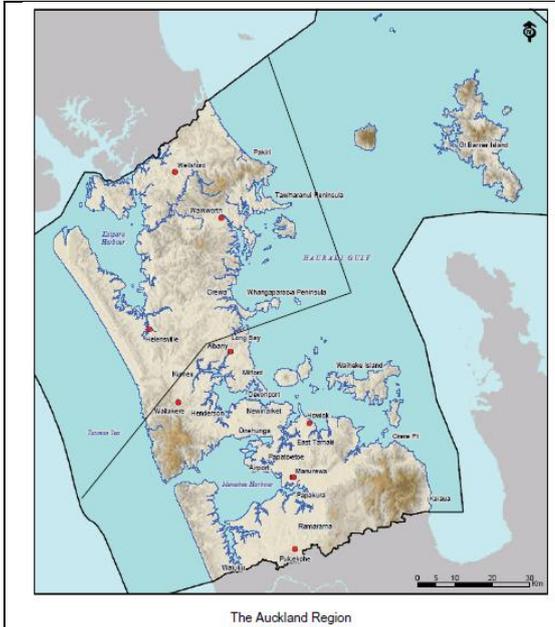
Figure 3a – The Auckland Region, Taken from Auckland Regional Risk Assessment (Reference 14) showing the area falling under the responsibility of the Auckland Harbourmaster and to which the Assessment applies.

Under a Memorandum of Understanding between the former Rodney District Council (RDC) and the ARC, RDC administered a distinct area shown in figure 3a below. Orewa Beach falls within this area.

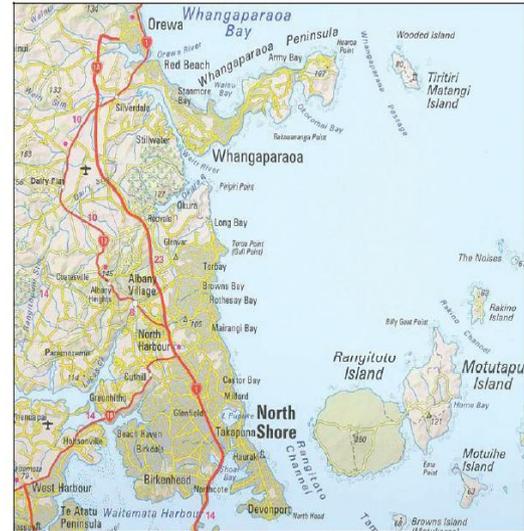
Figure 3b. Map showing the limits of area considered in section 5.2 of the Auckland Regional Risk Assessment (Reference 14) and in which Orewa Beach lies

The Assessment considered the various areas of the region in turn. Orewa Beach lies at the northernmost end of the area described as "Whangaparaoa Peninsula and North Shore Area" and is considered in section 5.2 of the assessment (Figure 3b). The section looks at a number of specific localities. Orewa Beach is not among them.

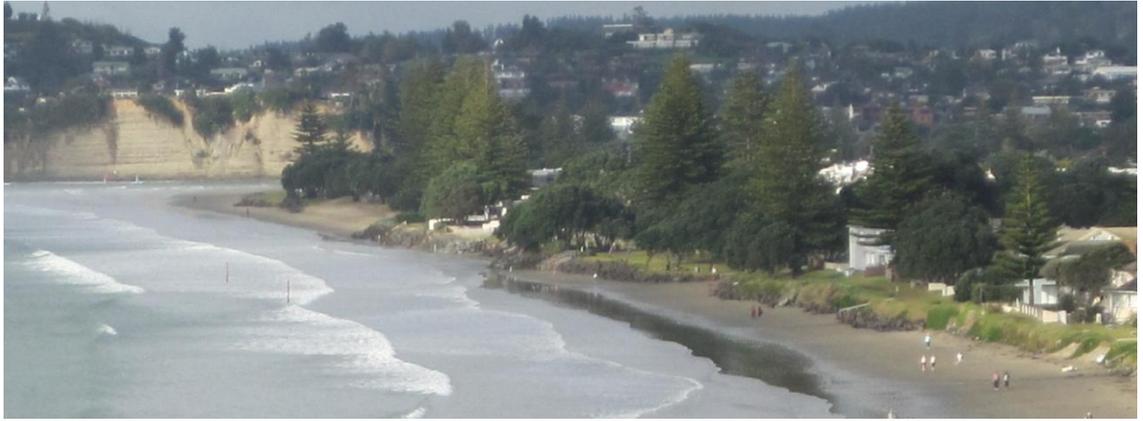
↑ Southern seaward marker, Orewa Beach ski access lane
↑ Northern seaward marker, Orewa Beach ski access lane

Figure 4 Marine View Rd, Boat ramp and access lane markers. 8 June 2011, 2 hours before High Water, taken from lookout point on SH1 looking south

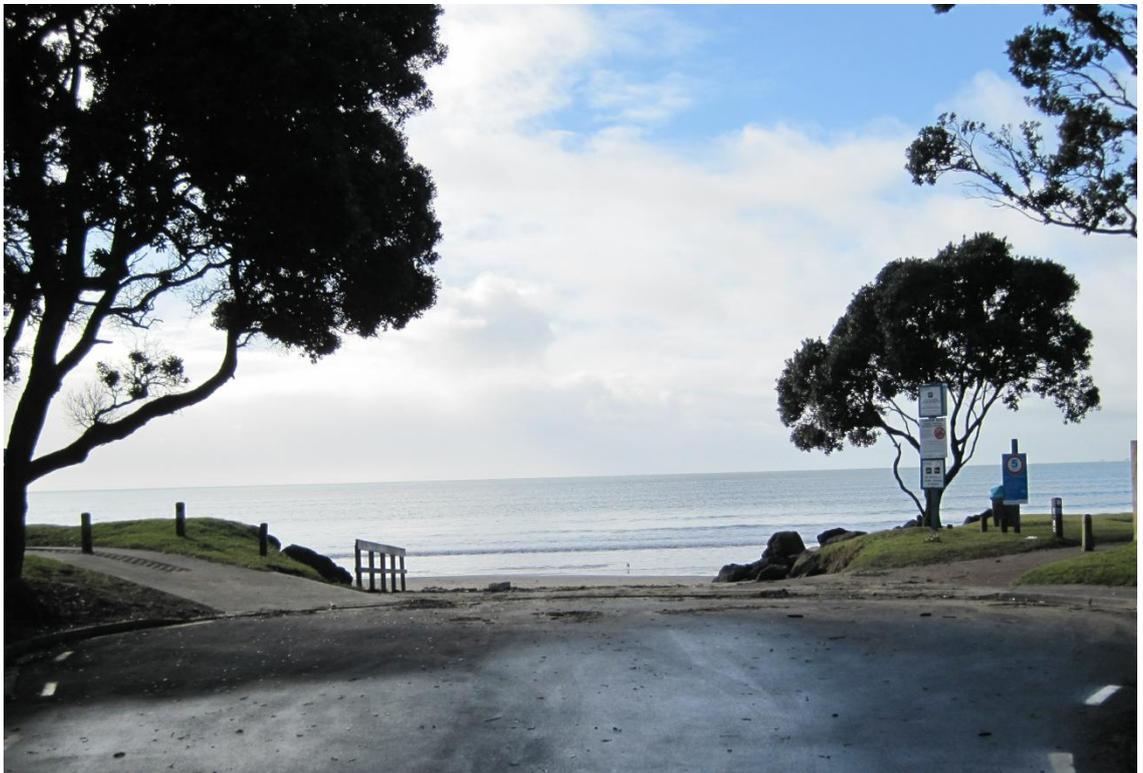
Figure 5 – Marine View Rd, Boat Ramp looking seaward

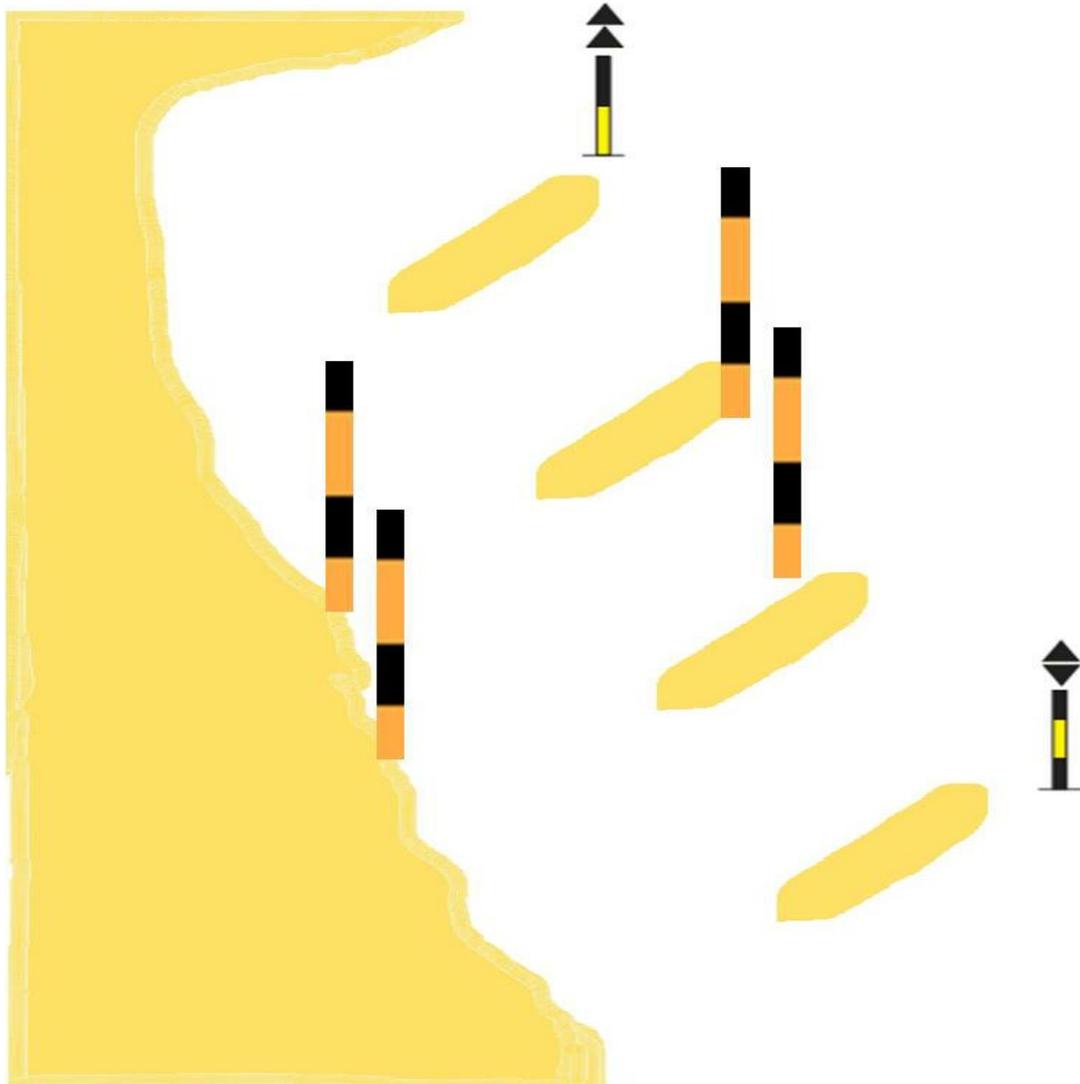
The figure below shows a minimalist scheme of navigation marks to mark the reefs. Two cardinal marks to the north and east of the reefs delineate the extremes and an access lane is marked.

Figure 8 Minimalist scheme for marking the proposed reefs. (diagrammatic – not to scale)

A south cardinal mark could be added to the south of the inshore end of the southernmost reef especially since there is a boat launching ramp from the motor camp a short distance to the south.
